DTE Energy®

Ice Storm – December 2013
House Energy and Technology Committee

Trevor F. Lauer
Vice President of Distribution Operations
January 21, 2014

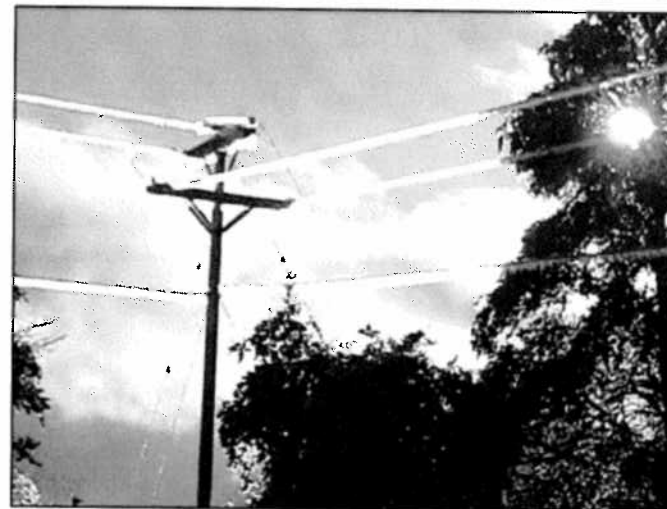
Tree falling in front of a DTE truck caused additional outages after restoration had been completed

Ice covered power lines

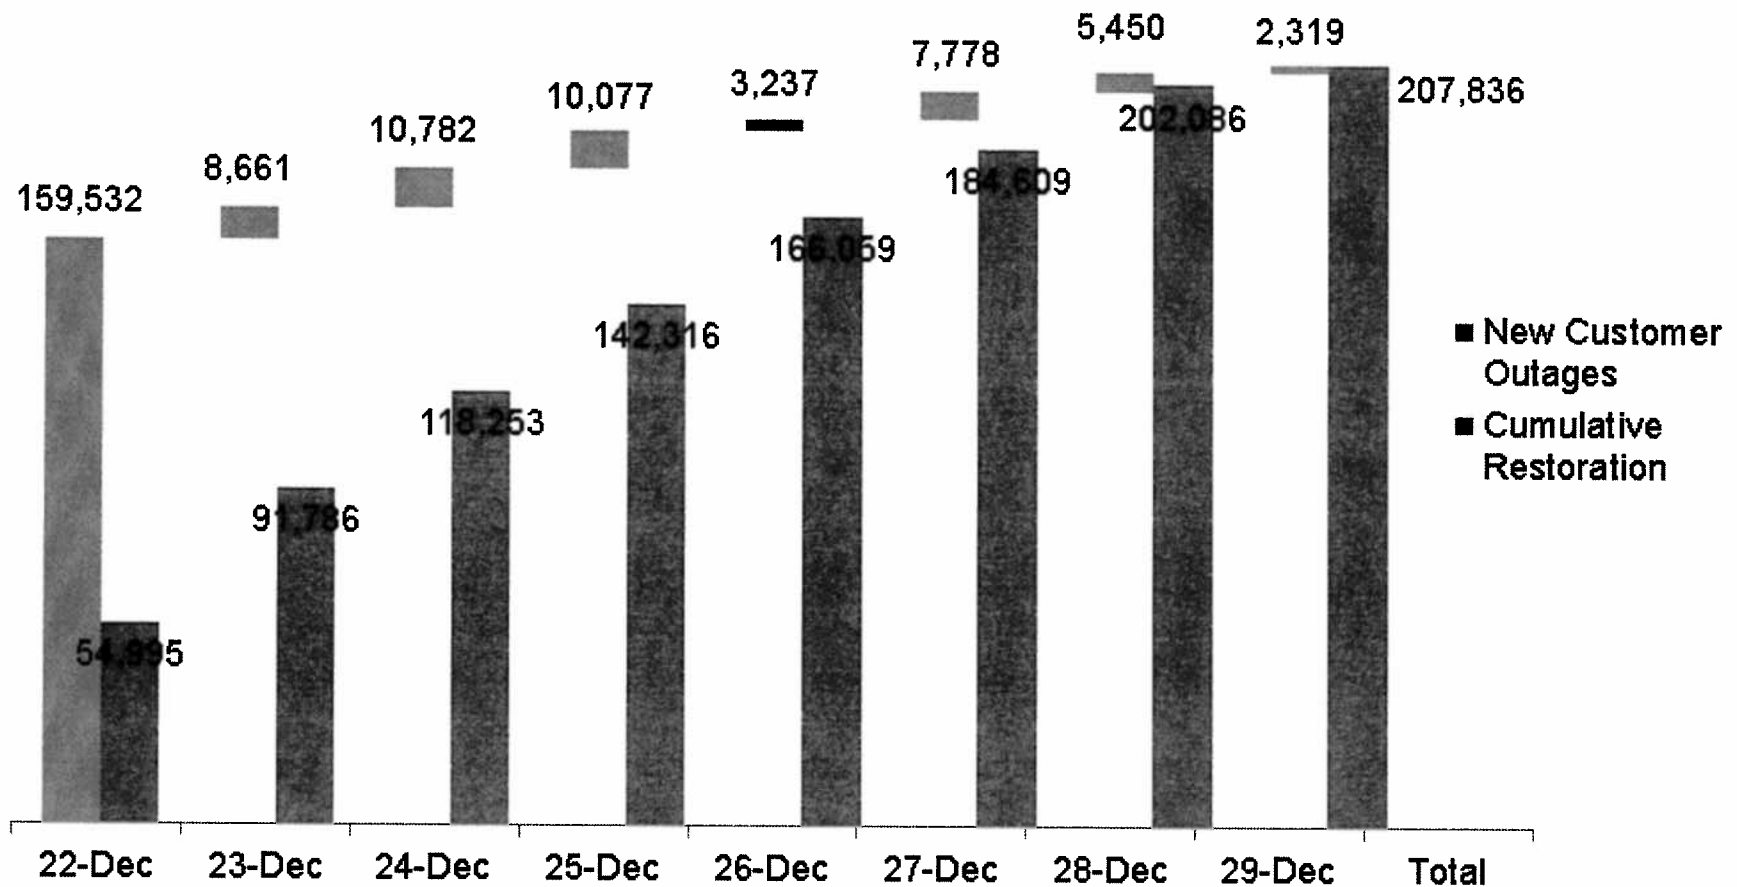
New Customer Outages and Restoration per day

Ice storms caused ongoing outages, slowing down restoration efforts

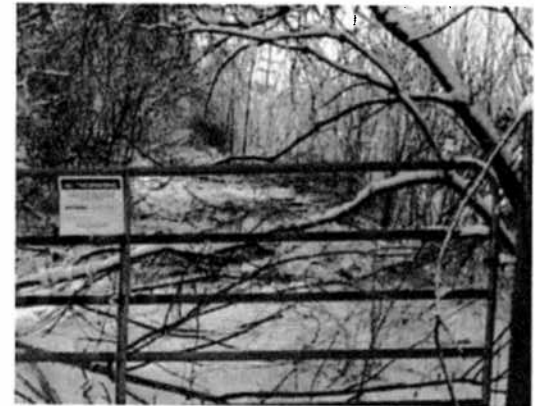
BEFORE

Work Performed

2,300 wire downs

206 poles replaced

19 miles of wire replaced

44 transformers replaced

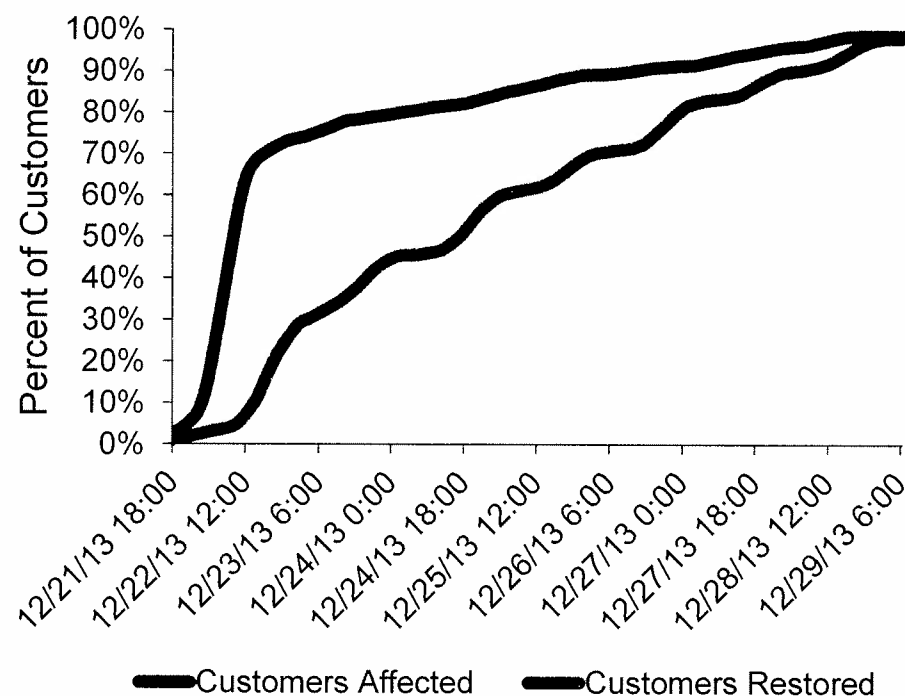
- Approximately 210,000 customers impacted
- Last customer restored at 6 pm on Dec 29

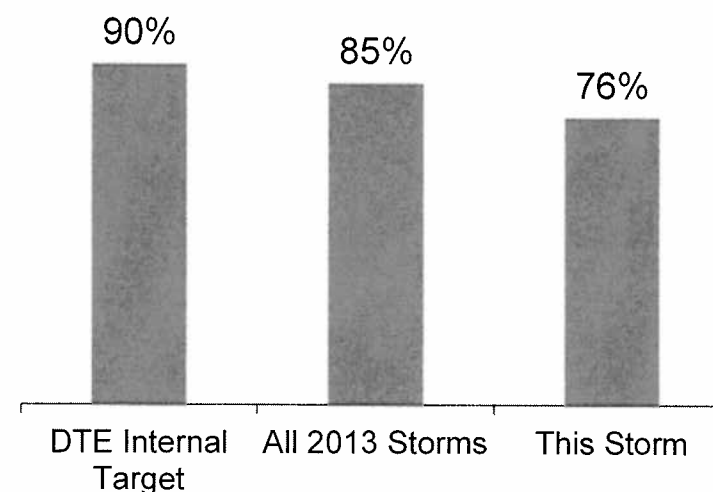
Customer Restoration Estimate Performance

Challenges:

- Ongoing damage due to ice build-up
- Under-estimation of damage
